## Attack of the Clones

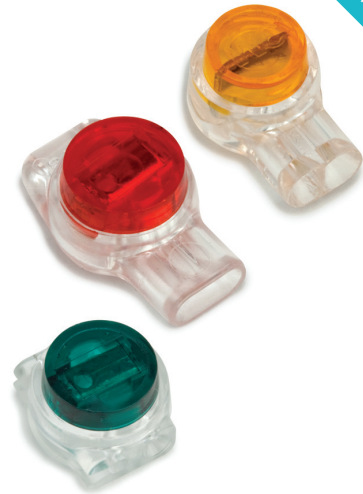
**Recognize this?** This is a discreet insulation displacement connector (IDC) manufactured by 3M. Or is it? It could be a clone manufactured in Asia. Knock-off connectors started showing up in the telephone industry many years ago. I'm sure that 3M is just one of many victims of knock-offs, and not just from Asia but anywhere in the world where they can make products for less and market them effectively. While some knock-offs are good quality, many aren't.

Let me give you some info on ways to determine if you are looking at a clone or looking at the real thing. And in some cases it isn't easy. Look for the supplier logo and make sure it's the right supplier logo. If you are in any doubt about the quality and maybe even the origin of discreet connectors in your network, call your local vendor's representative sales contact. These folks are trained to help you, and they love helping solve a problem that wasn't created by their product in the first place!
